Weston Solutions, Inc.
7800 West Outer Drive
Suite 200
Detroit, MI 48235
Phone: (313) 739-2533

September 25, 2009

**Subject: Site Assessment Letter Report
Westover Landfill Site
Oregon, Lucas County, Ohio
Technical Direction Document No.: S05-001-0906-025
Document Control No.: 680-2A-AETT
Work Order No.: 20405.012.001.0680.00**

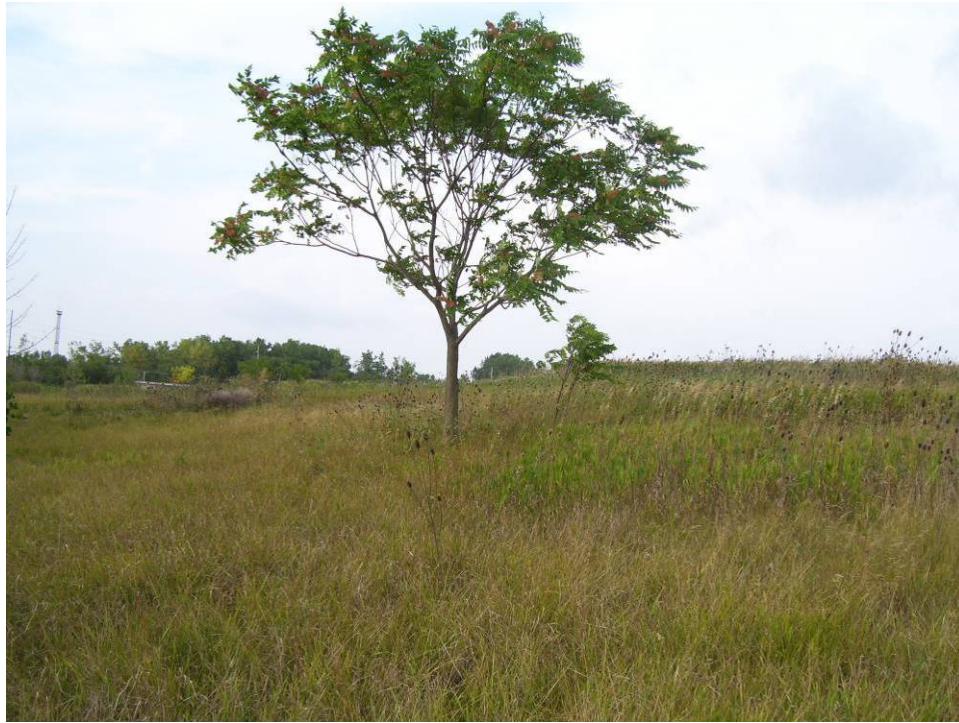
Photo Number: 003

Subject: Trees growing on the landfill cap, north end of the Site

- Removal and disposal of all trees and invasive phragmites vegetation from the landfill cap, and reseeded with appropriate cap vegetation;
- Reinforcement or replacement of the leaking plug in the storm water outfall pipe at the northwest corner of the Site to halt the chronic discharge of leachate-contaminated water to Otter Creek and prevent a complete failure of the plug;

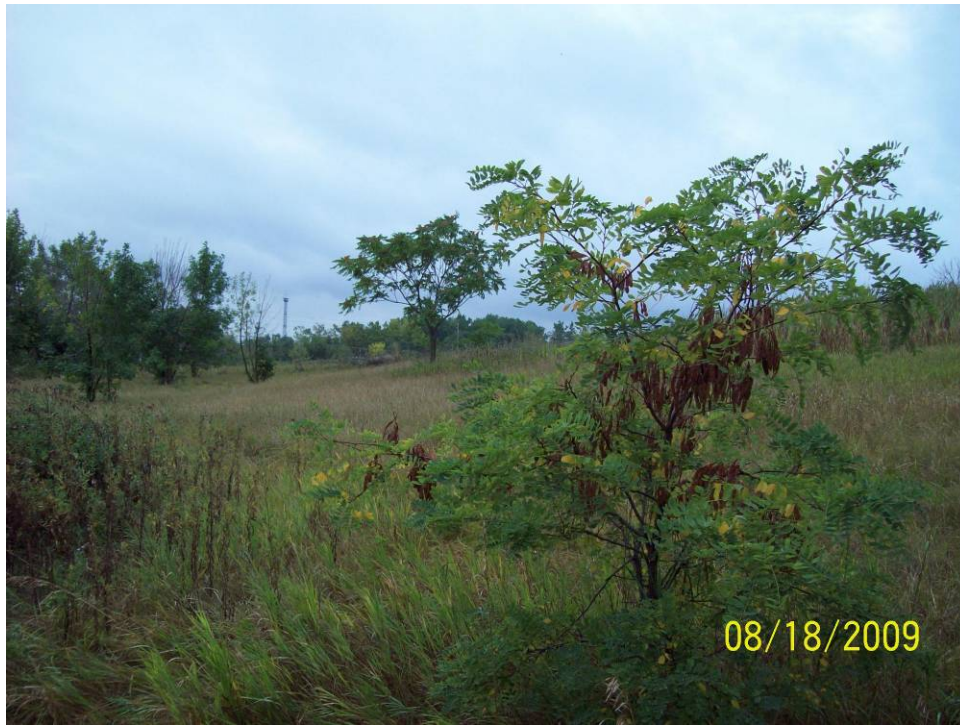
Photo Number: 005

Subject: Trees growing on the landfill cap, north end of the Site

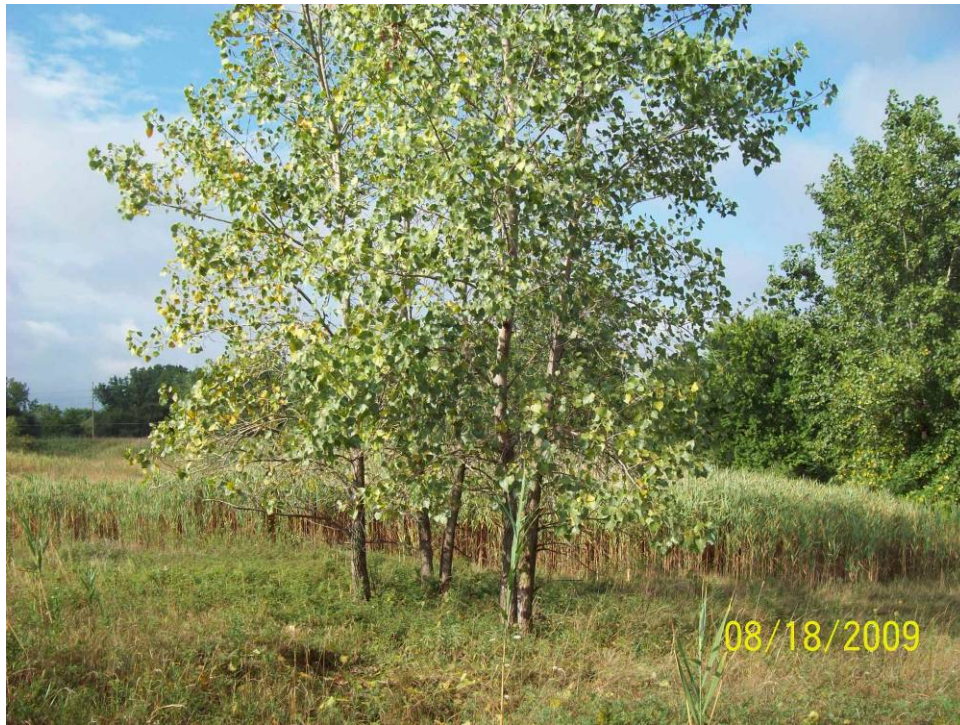
Photo Number: 007

Subject: Trees growing on the landfill cap, west side of the Site

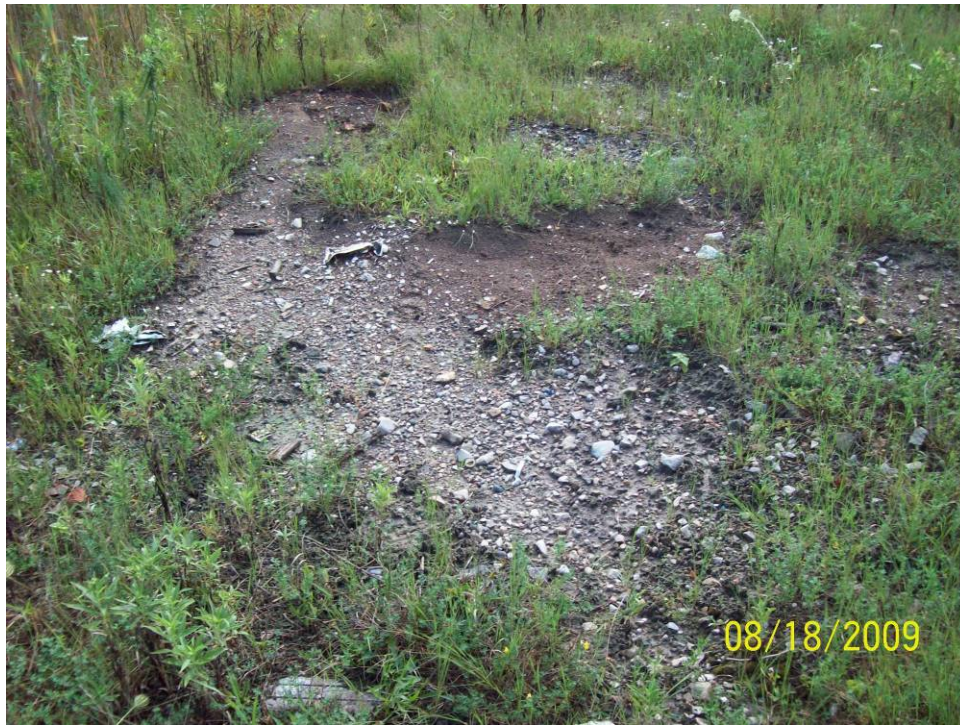
Photo Number: 009

Subject: Distressed vegetation and washout on the landfill cap, west side of the Site

- Improvements to the clay cap and existing storm water control structures to reduce leachate outbreaks at the surface and prevent infiltration into the storm water control system and Otter Creek;

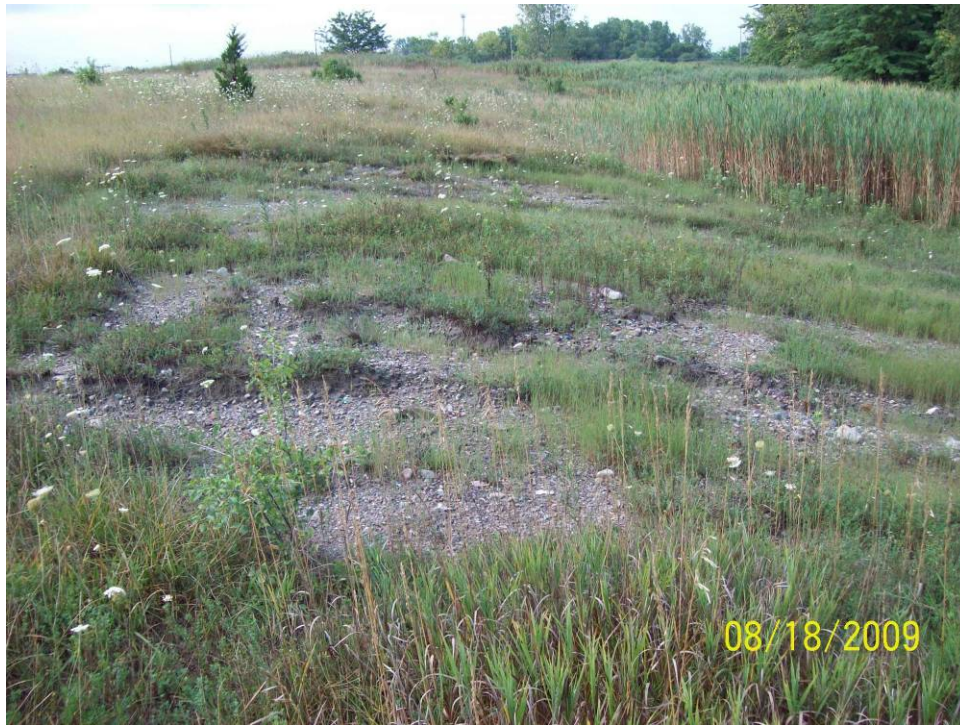
Photo Number: 011

Subject: Distressed vegetation and washout on landfill cap, west side of the Site

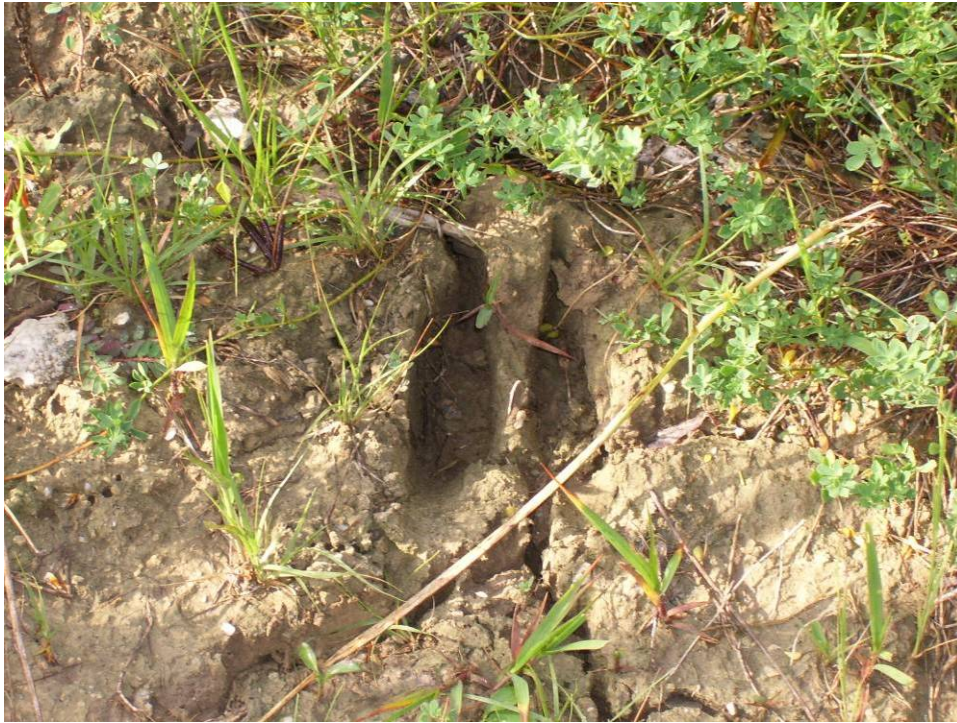
Photo Number: 013

- signs of animal habitation on the landfill cap, including deer tracks and numerous daytime bedding areas;
- at least four areas of distressed vegetation on the landfill cap;

Subject: Deer tracks inside the landfill fence line, west side of the Site

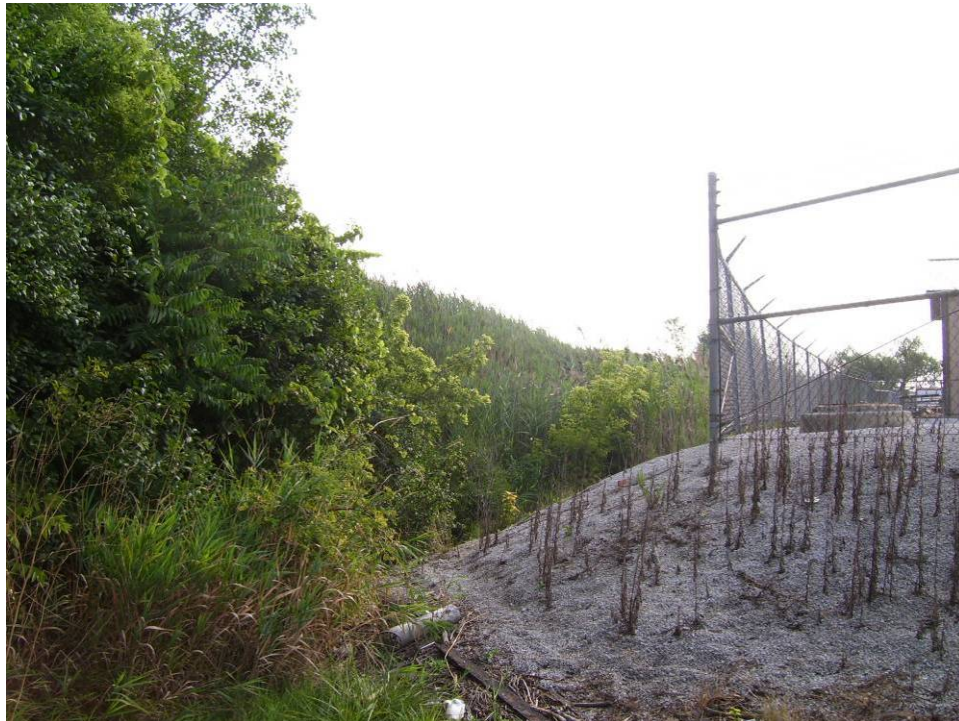
Site: Westover Landfill Site Assessment, Oregon, Ohio
Photo Number: 016
Direction: East
Subject: Drainage ditch along southern property line of site, landfill to the left

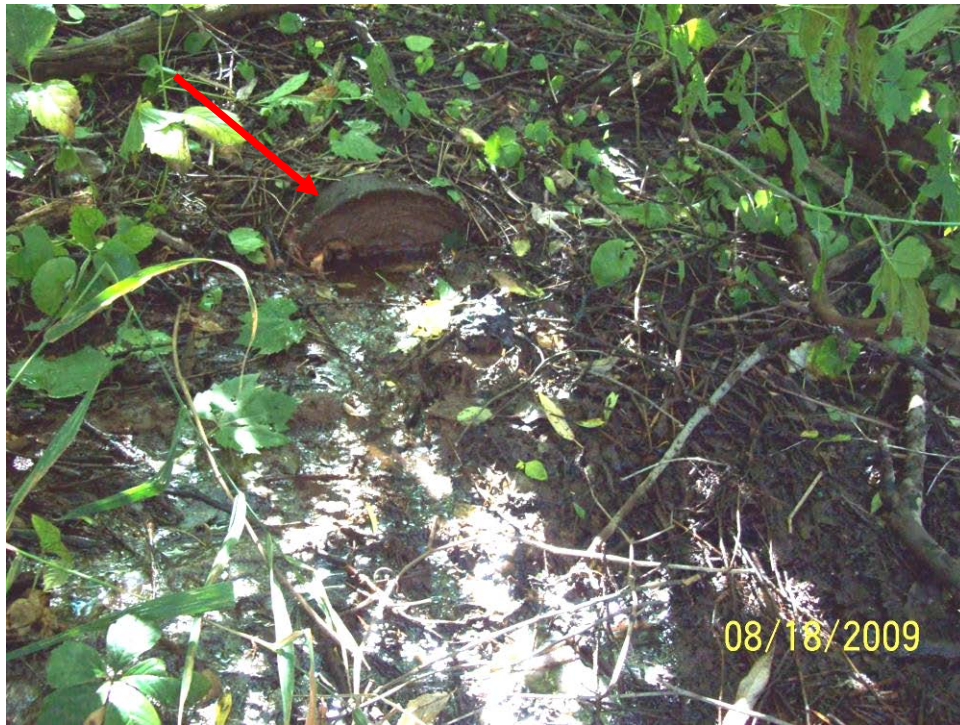
Photo Number: 017

- uncontrolled leachate-contaminated water discharging continuously into Otter Creek at a rate of 0.20 – 0.22 liters per minute from the northwest storm water outfall pipe;

Subject: Plugged but leaking storm water outfall pipe at the northwest corner of the Site

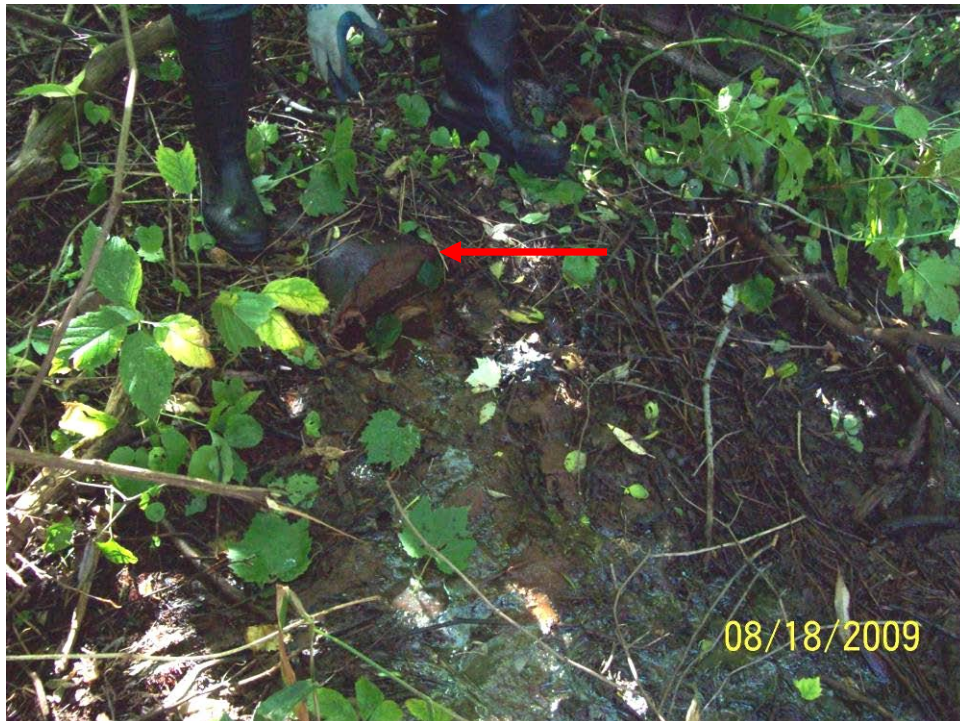
Photo Number: 018

Subject: Plugged but leaking storm water outfall pipe at the northwest corner of the Site

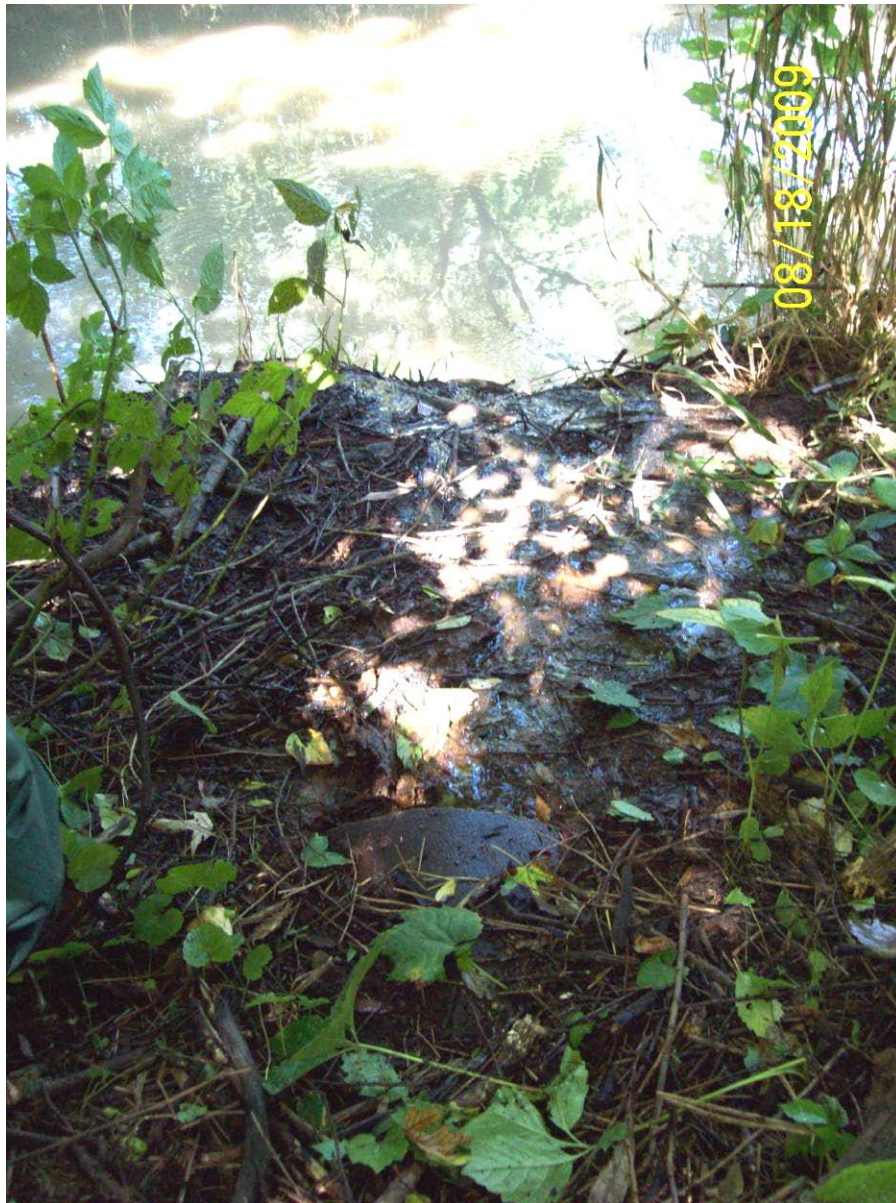
Photo Number: 019

Sample results indicate that the storm water discharge from the northwest outfall pipe exceeded the State of Ohio Generic Unrestricted Potable Use Standards in Ohio Administrative Code (OAC) 3745-300-08(D)(3)(b) and 3745-300-08(D)(3)(c) for concentrations of arsenic and benzene. The conductivity readings collected from the northwest storm water outfall also confirmed elevated concentrations of dissolved ions when compared to the conductivity readings collected from surface water in Otter Creek (Table 1). Free flowing leachate-contaminated water was observed to be discharging continuously into Otter Creek at a rate of 0.20-0.22 liters per minute from the formerly-plugged steel storm water outfall pipe near the northwest corner of the Site. Leachate outbreaks have also been documented at the top of the southwest storm water letdown structure that discharges into Otter Creek via the outfall at the southwest corner of the Site.

Subject: Leaking storm water outfall pipe at northwest corner of Site discharging into Otter Creek

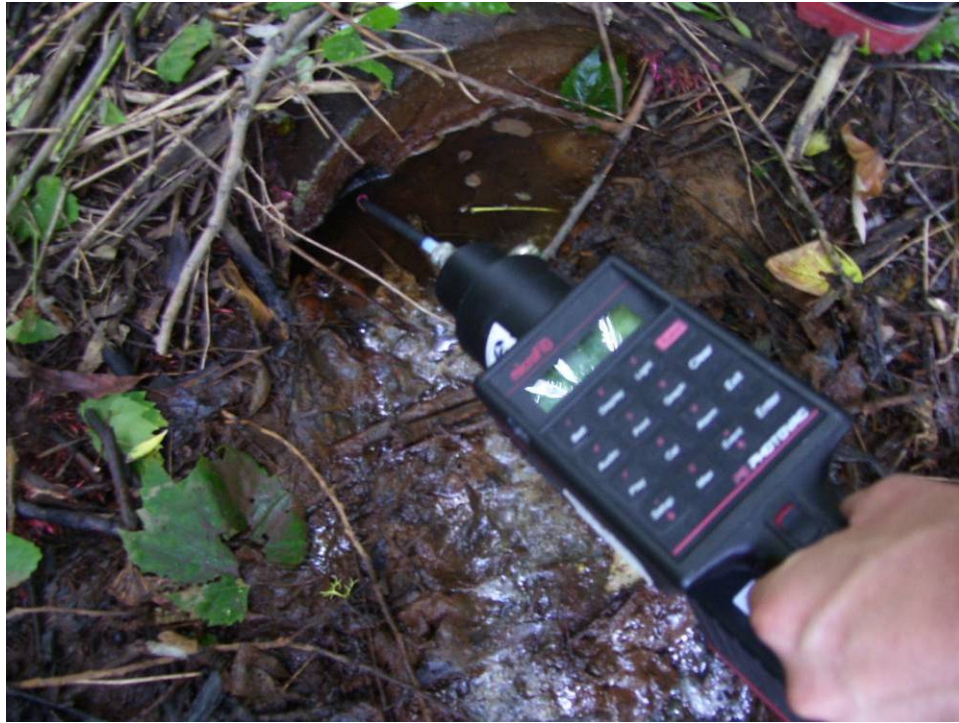
Photo Number: 020

- uncontrolled fugitive landfill gas emissions from the northwest storm water outfall pipe with air monitor readings ranging up to:
 - 50,000 ppm (instrument maximum range) total combustible organic compounds with the MicroFID;

Subject: Analyzing gases from the leaking storm water outfall with a flame ionization detector

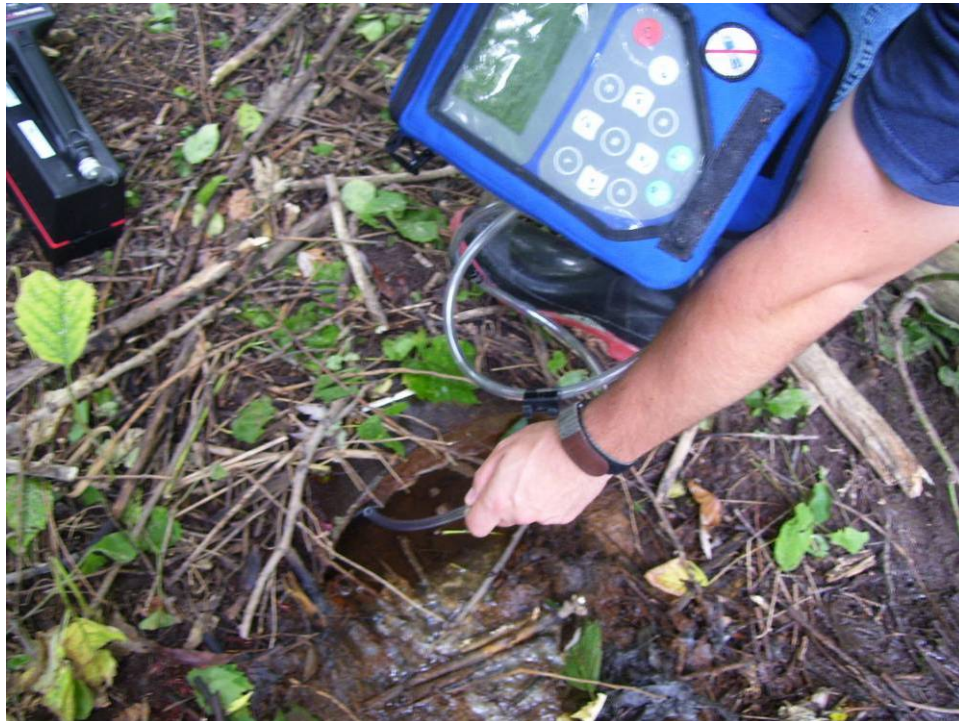
Photo Number: 021

- 57,000 ppm methane (CH₄) and 20,000 ppm carbon dioxide (CO₂) with the GEM 2000, and;
 - 23 percent lower explosive limit (LEL) with the MultiRAE Plus;

Subject: Analyzing gases from the leaking storm water outfall with a landfill gas monitor

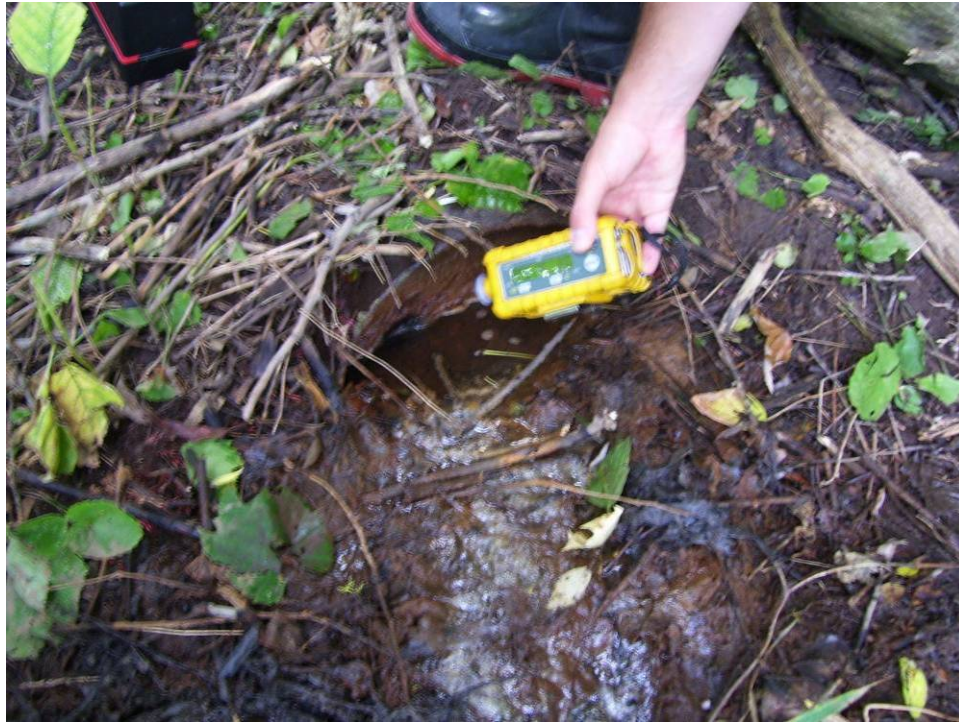
Photo Number: 022

Subject: Analyzing gases from the leaking storm water outfall with a photo ionization detector

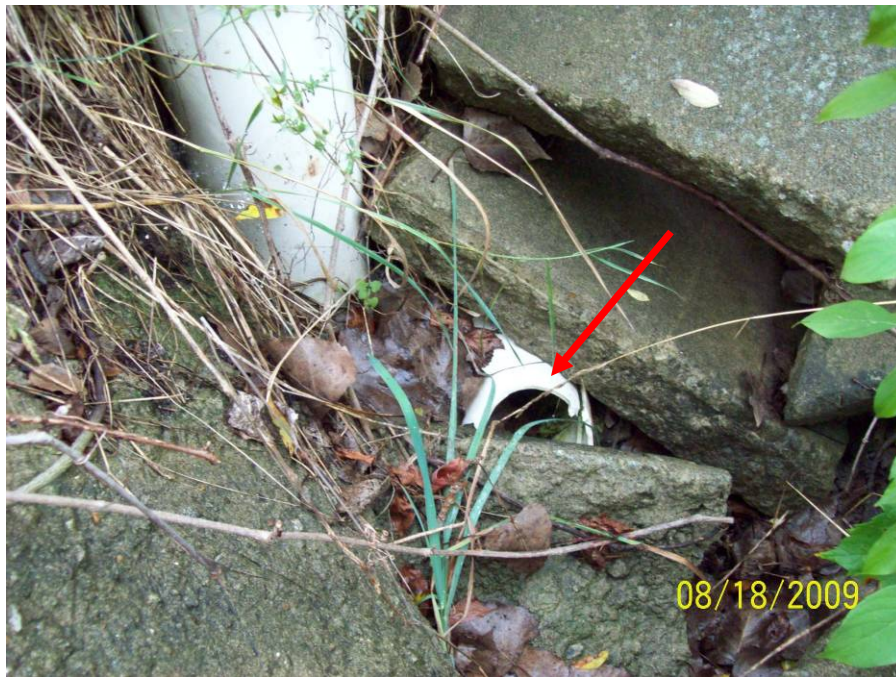
Photo Number: 024

- three outwash areas with downed vegetation and surface erosion on the western slopes of the landfill cap adjacent to Otter Creek;
- a 1-foot long shattered segment of buried PVC pipe amongst the rip rap at the base of the southeast letdown structure that was believed to be integral to the perimeter leachate collection system;

Subject: Broken PVC pipe beneath concrete debris, located near the leachate collection manhole and gas vent at the southeast corner of the Site

- Improvements to the leachate collection system to repair damaged PVC components at the southeast corner and western perimeter;

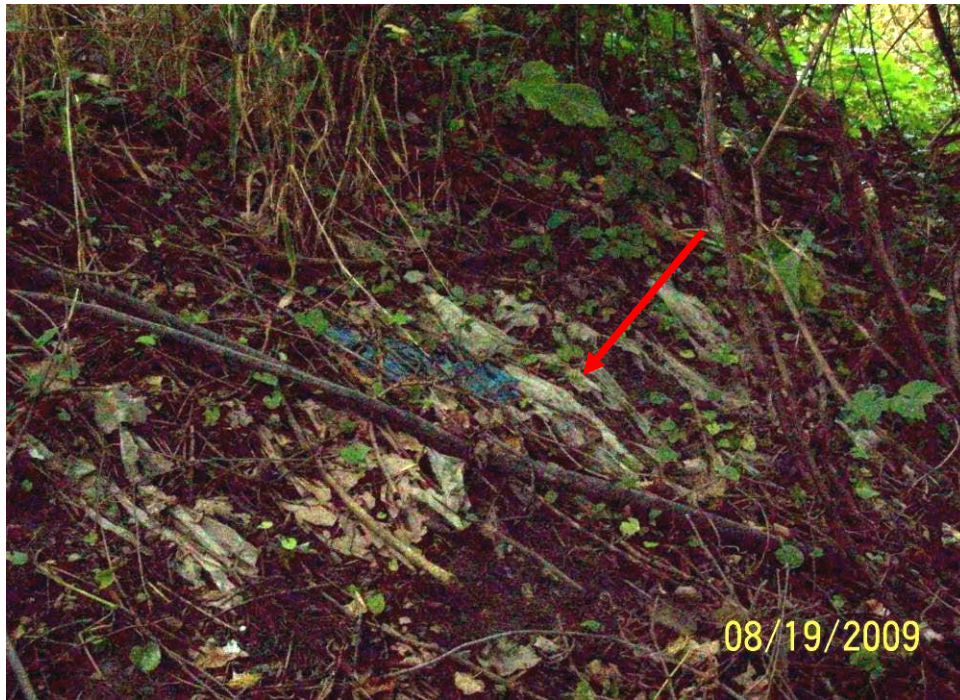
Photo Number: 026

Subject: Uncovered landfill debris on the west slope of the landfill, adjacent to Otter Creek

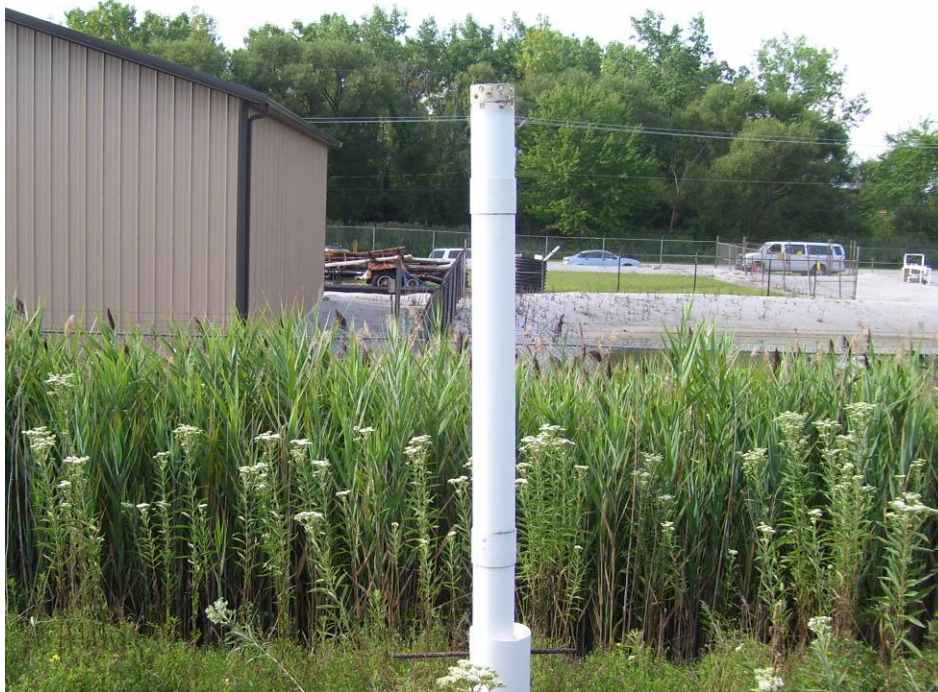
Photo Number: 027

- two methane vents with broken PVC risers and missing rain caps;
- START was unable to closely inspect the storm water outfall to Otter Creek located at the southwest corner of the Site due to vegetation and steepness of the adjacent slope.

Subject: Landfill gas PVC vent pipe with missing rain cap, on the south side of Site
